# CATALYTIC CONVERTER THEFT PREVENTION AND OUTREACH

TERRY O'NEILL  
ENGINEERING AND RESEARCH BRANCH  
BAR ADVISORY GROUP MEETING  
OCTOBER 21, 2021

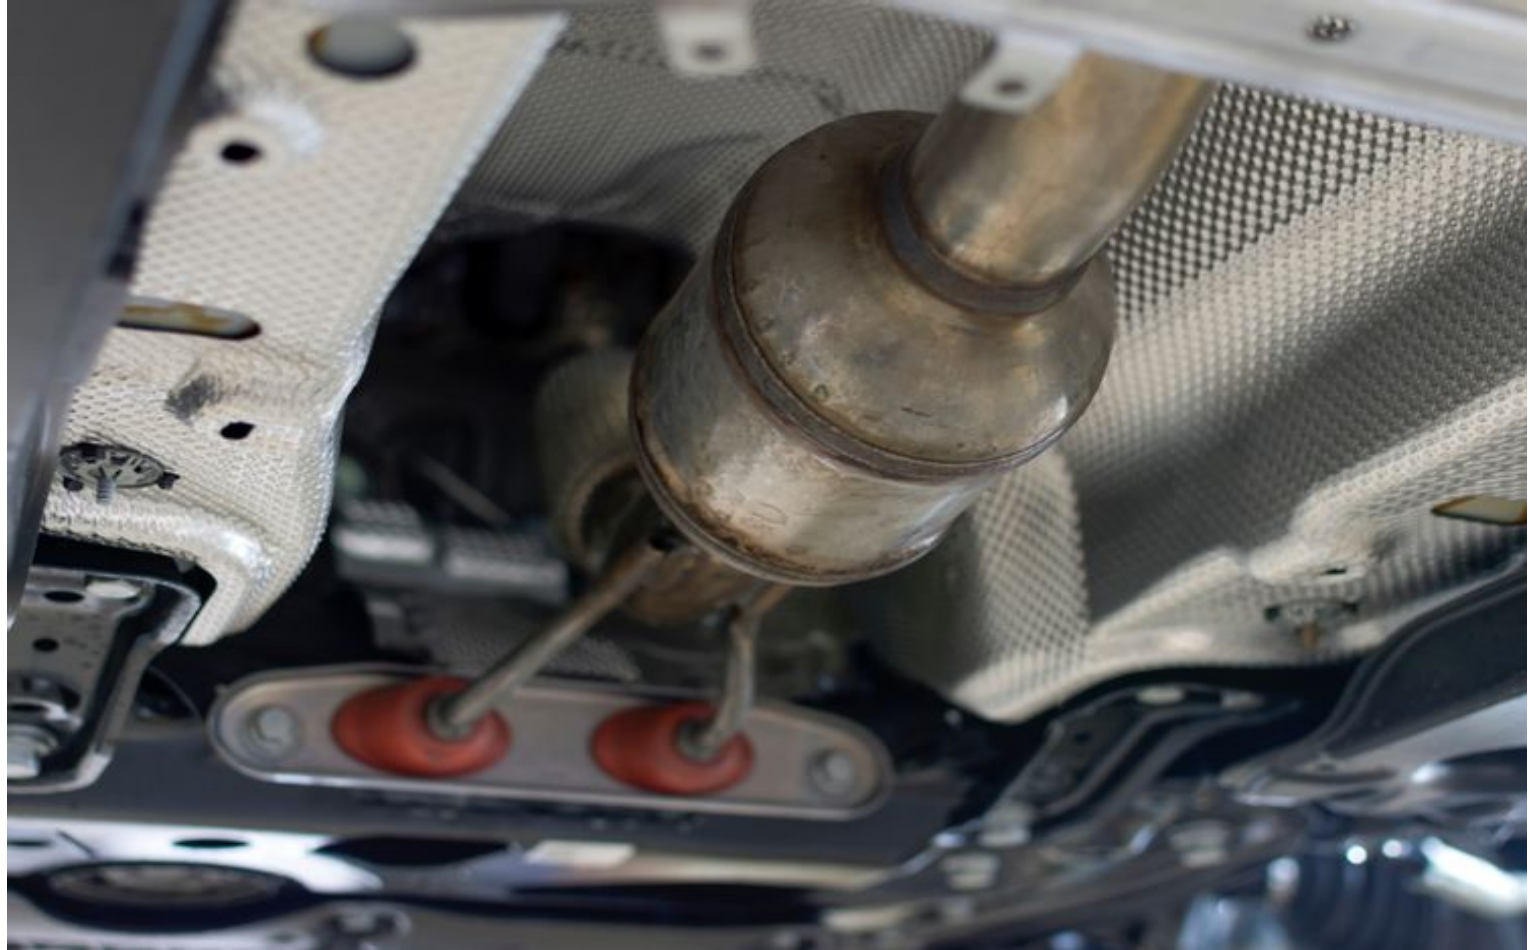
# MANY CONVERTERS ARE EASILY ACCESSIBLE

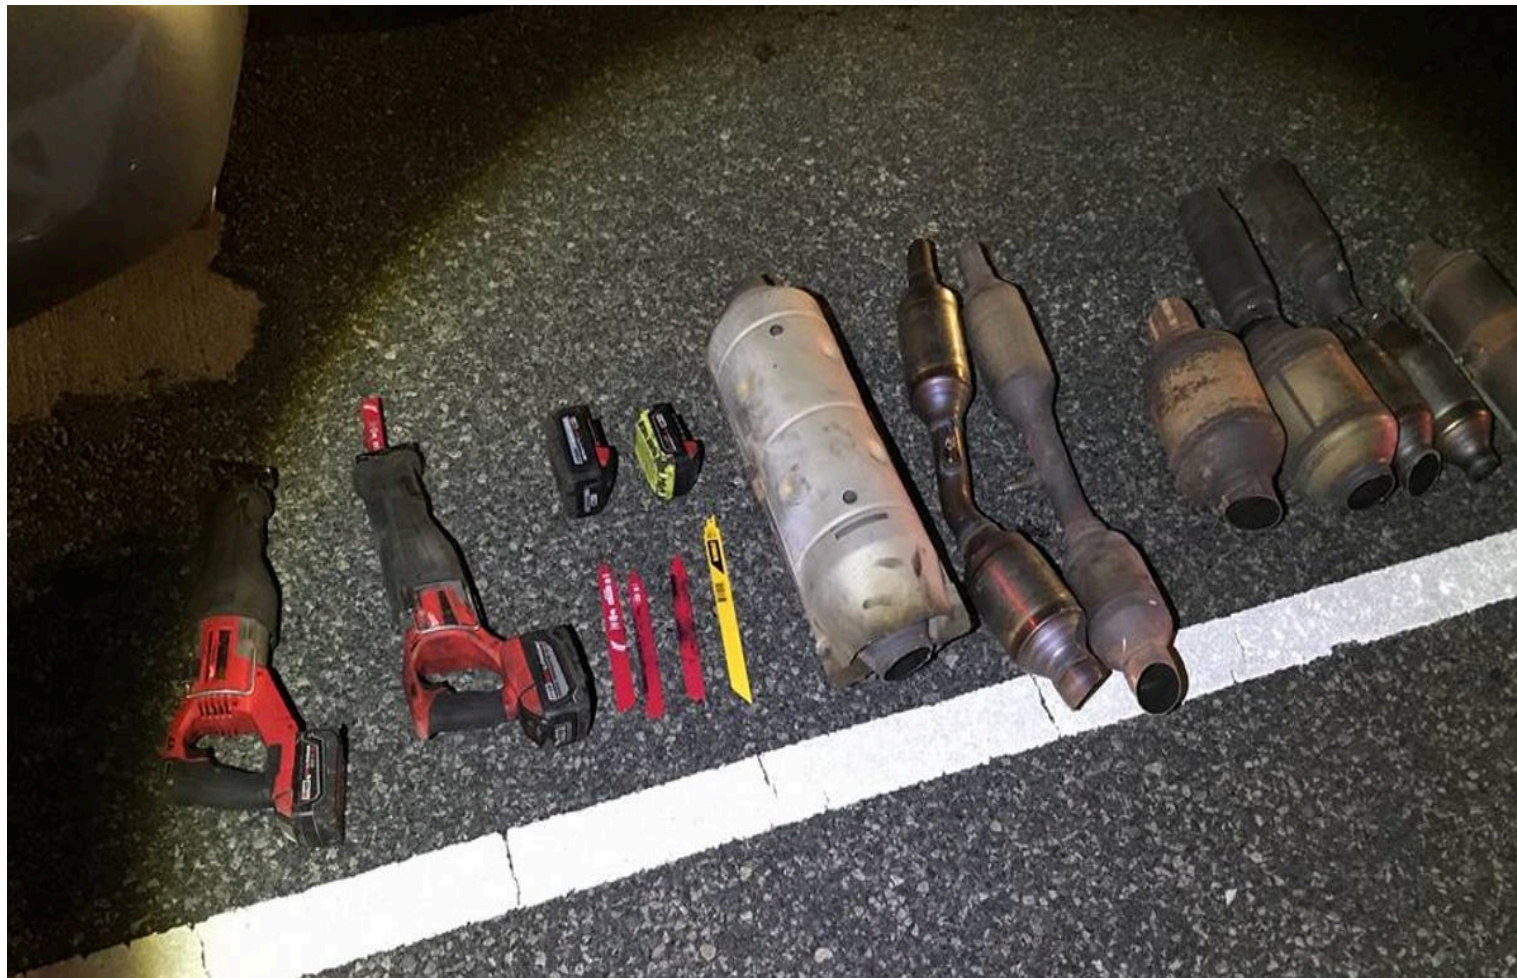
# RECOVERED TOOLS AND HARDWARE

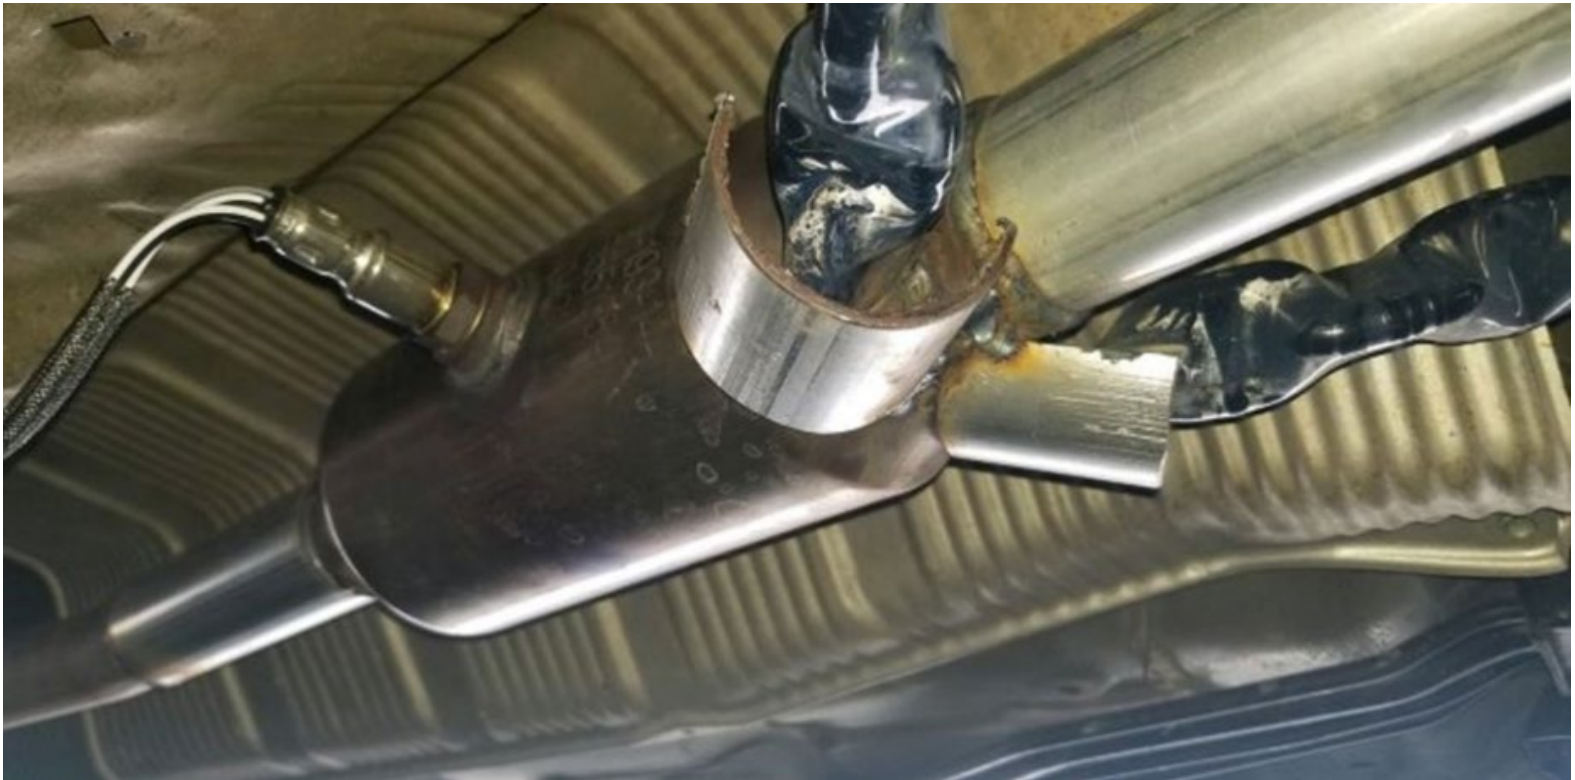
## SMOG CHECK VISUAL INSPECTION (1 of 4)

Example of converter welding that is not acceptable

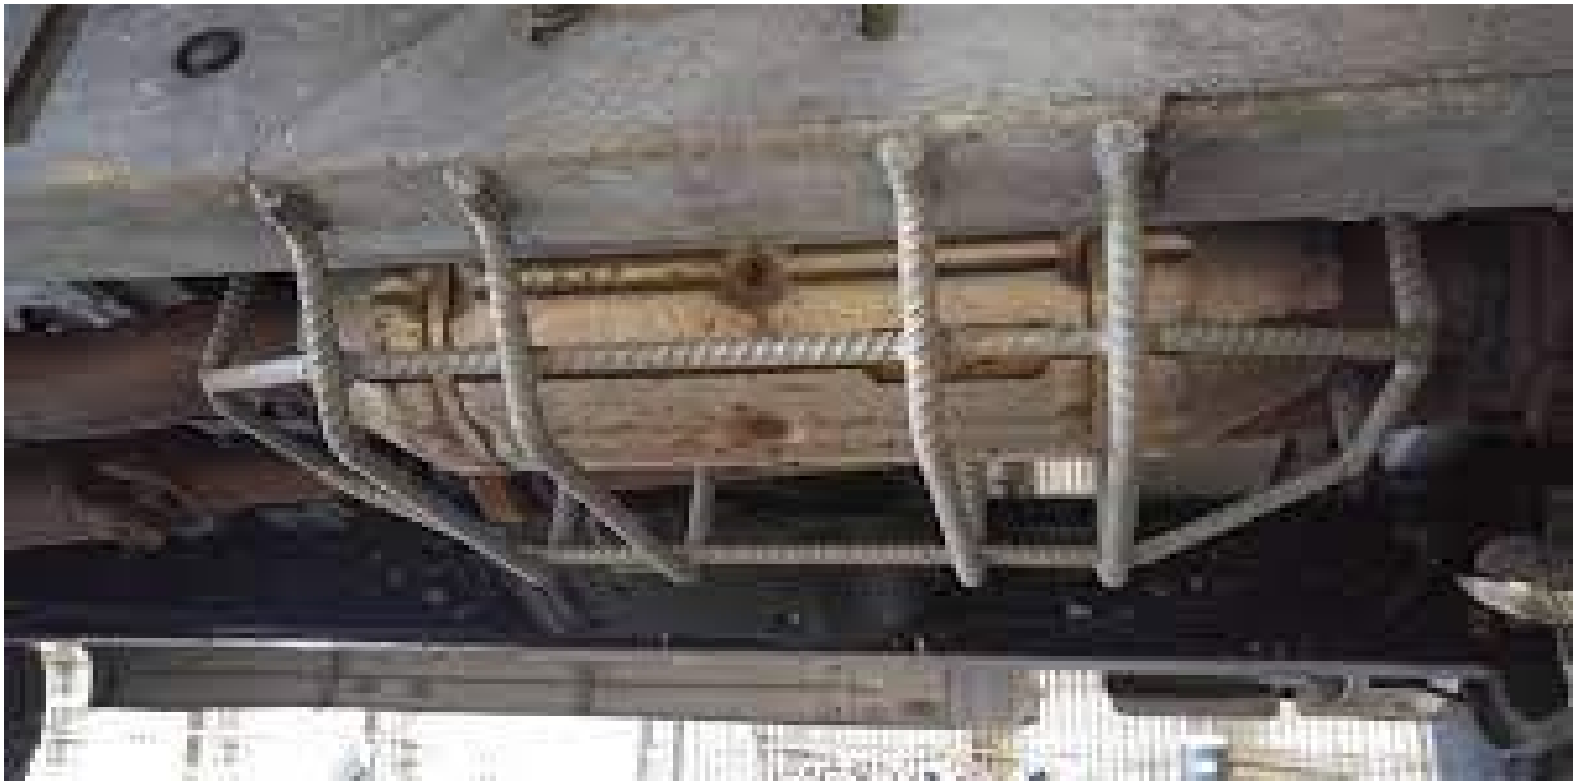
## SMOG CHECK VISUAL INSPECTION (2 of 4)

Example of a cage that allows visibility and does not interfere with the converter

- Consumers can help prevent catalytic converter thefts by parking in well-lit areas, installing motion sensing alarm systems, etching the converter shell with a vehicle identification or license plate number.
- Acceptable theft prevention devices appearing on the market include steel cages, chains, cables, and shields; all of which may make the converters difficult to steal. Permanent devices must only be placed around and not touching the converter shell.
- The theft prevention measures should not be welded to the converter and must retain complete visibility of the part for Smog Check purposes, and that proper ventilation is maintained to prevent a safety concern.

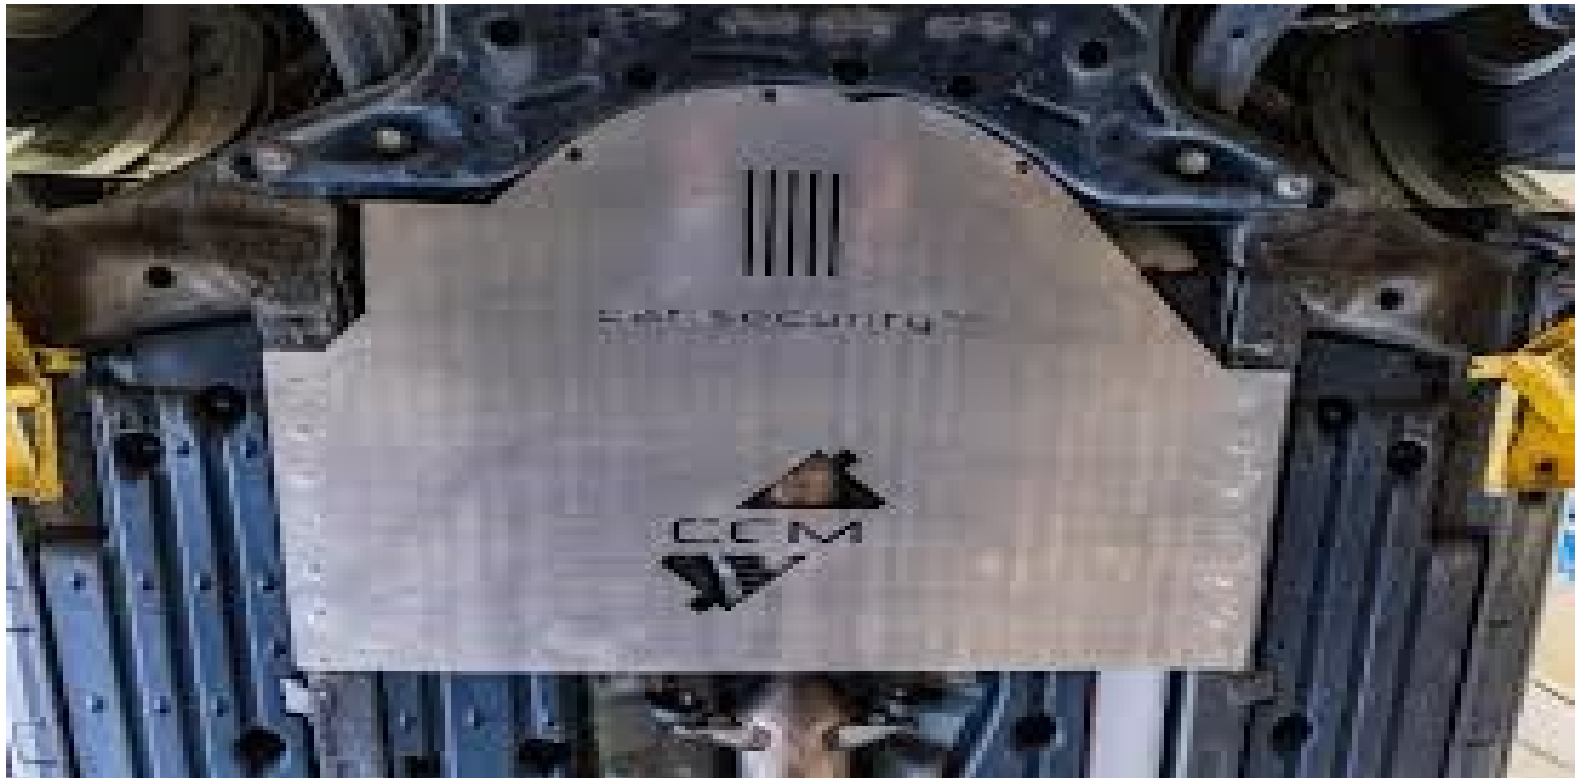
## SMOG CHECK VISUAL INSPECTION (3 of 4)

Example of a shield that may require removal prior to a Smog Check

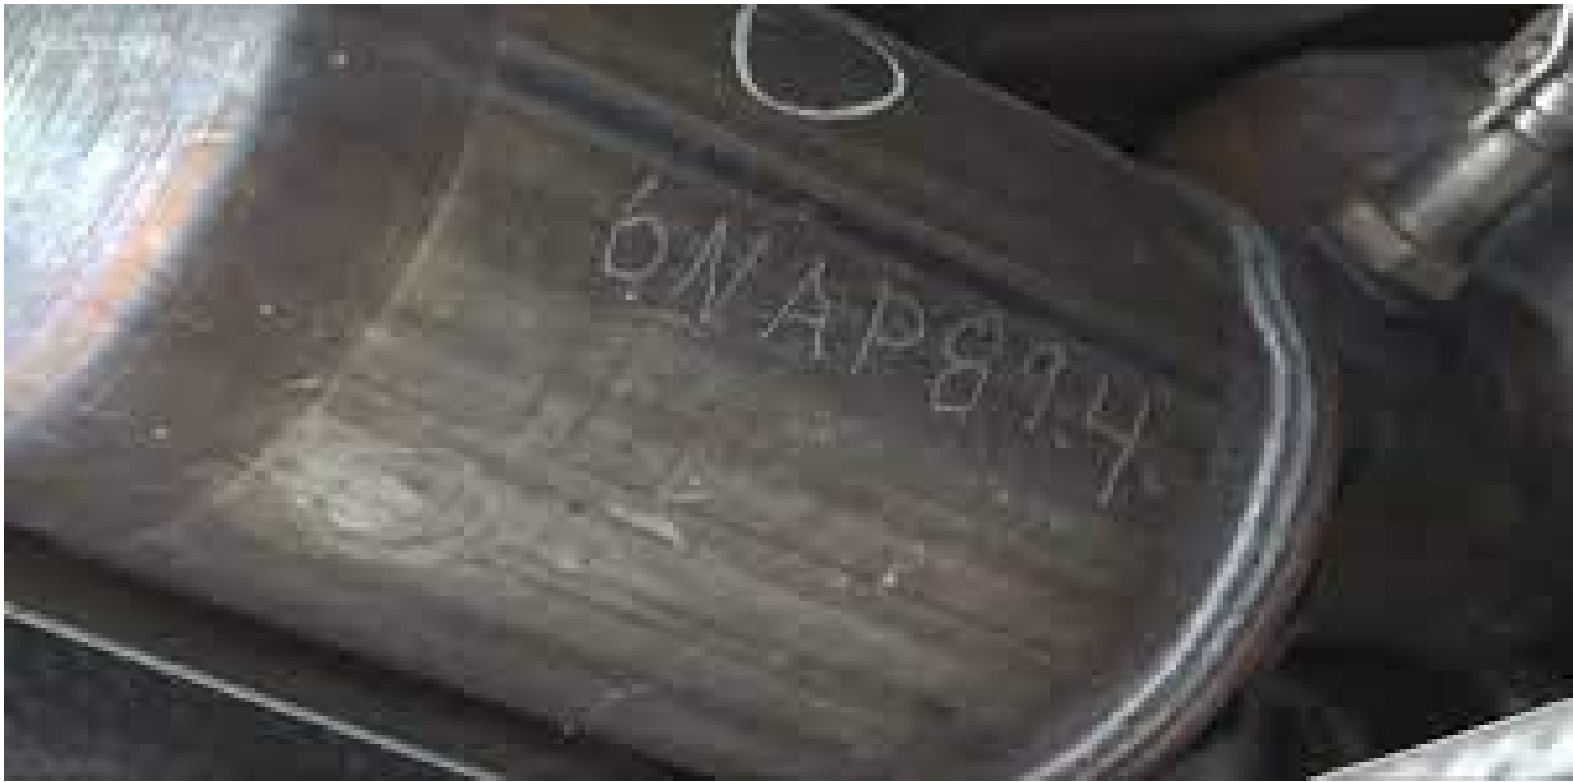
## SMOG CHECK VISUAL INSPECTION (4 of 4)

Example of a converter that has been etched with a vehicle license plate. The performance of the converter has not been compromised and is not a Smog Check failure.
